- ENGINEERING MEDIEVAL CATHEDRALS

BEAUVAIS CATHEDRAL

STRUCTURAL ANALYSIS AND COMPARISON

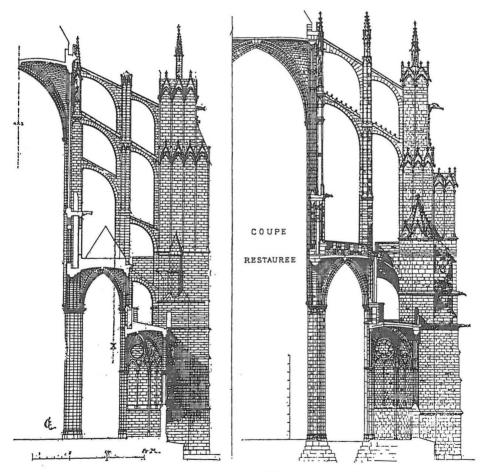
Fig. 2. Typical bay by Corroyer. Fig. 3. Coupe restorée by Benouville. Beauvais Cathedral: part cross-sections of the choir.

Benouville's analysis consists in the drawing of force polygons for a dozen sections of his crosssection, Fig. 3, and he evidently considers this exercise to be so straightforward (as do the Editors of

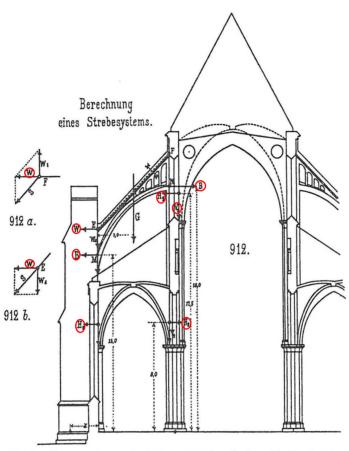
Fig. 5. Forces acting at a typical cross-section of a large Gothic church (Ungewitter).

Ungewitter quite frankly uses a final desired force distribution to calculate the magnitude of the buttress force. In Fig. 5, reproducing Ungewitter's Fig. 912, Plate 87, are shown the main forces acting on a typical cross-section. Considering first the main pier, Ungewitter determines the high vault thrust H_1 and vertical reaction V_1 , and similarly the aisle vault thrust H_2 and reaction V_2 . Making allowance for weights of walls, and so on, carried eccentrically by the pier, the question is then asked as to the magnitude of the buttress thrust B necessary for the total thrust line to pass precisely through the mid-point of the pier at the base.¹ If moments of the forces are taken about this midpoint, the value of B is then determined immediately (in Ungewitter's example, for which $H_1 = 3.24$ tonnes, the value of B is found to be 3.02 tonnes).

It will be seen in Fig. 5 that the flying buttress consists of two ribs, of which the lower is curved, both conducting the calculated thrust B to the main external buttress and also supporting the upper straight rib. Ungewitter assumes that this upper rib is normally free of load, but acts as a wind brace, necessary for the support of the upper part of the structure. The load W shown acting on this

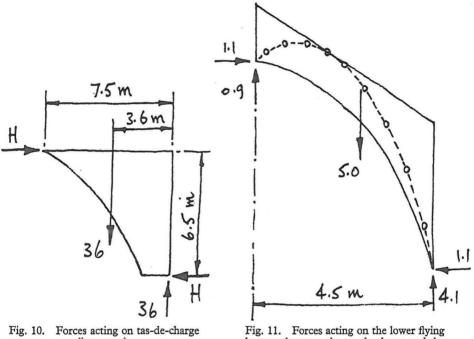
Beauvais Cathedral.

The outline of the lower flying buttress, spanning 4.5 m. between the tas-de-charge and the intermediate pier, and weighing about 5.0 tonnes, is shown in Fig. 11. The dotted line is the trace of the

passive line of thrust,¹ corresponding to the minimum possible horizontal thrust necessary for stability of the flying buttress (i.e. in the absence of a vault, the buttress would, in any case, thrust against the tas-de-charge with a force of minimum value, in this example, of 1·1 tonnes). Thus the upper flying buttress, normally unloaded, also pushes against the fabric with a minimum thrust of approximately the same magnitude.

buttress would have had to span 9.5 m. instead of the 4.5 m. of Fig. 11. Rules of design were numerical rules; the buttress of 9.5 span, would, almost certainly, have been geometrically similar to that of 4.5 m. span, i.e. all its proportions would have been increased in the same ratio, 9.5/4.5. Scaling up Fig. 11 in this *linear* ratio, all the forces should be increased by the factor $(9.5/4.5)^1$, i.e. the larger flying buttress would weigh some 47 tonnes, and the minimum passive buttress thrust becomes 10.3 tonnes. The lower buttress would still be satisfactory, since it would transmit some proportion, between 10.3 and 20 tonnes, of the full vault thrust of 20 tonnes.

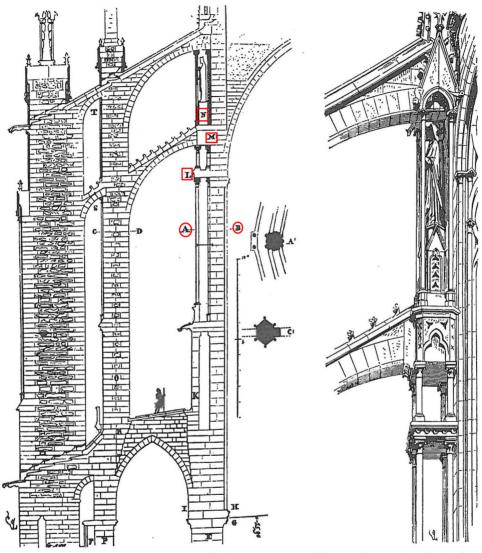
Fig. 12. Part cross-section at the chevet.

His cross-section is shown in Fig. 12¹; this cross-section is not of the typical bay, but is taken at the chevet, where the ground plan, Fig. 1, permits the main external buttresses to be placed closer in. A perspective sketch is given in Fig. 13.²

Viollet-le-Duc considers that the slender twin columns A (Fig. 13) failed.³ The mortar, slowly drying in the adjacent pier B, shrank (perhaps because the work was too hastily done, as Benouville believes), and more and more load was thrown onto the twin columns until they eventually fractured. As a consequence, the lintel L broke, and the great block M, the tas-de-charge, loaded by the gigantic statue N, was no longer supported. Viollet-le-Duc then considers that gross deformation occurred, which is plausible enough. He suggests that the block M slid out. It is more likely, however, that the block M would tilt outwards and so drive the line of thrust (shown broken in Fig. 11) outside the section of the flying buttress which would then collapse. There would be nothing to counteract the vault thrust; the vault would then collapse in that bay, almost certainly completely across the choir, so that at least one complete bay of vaulting would fall. The collapse would be likely to spread, since each bay of vaulting buttresses the next in an axial direction.

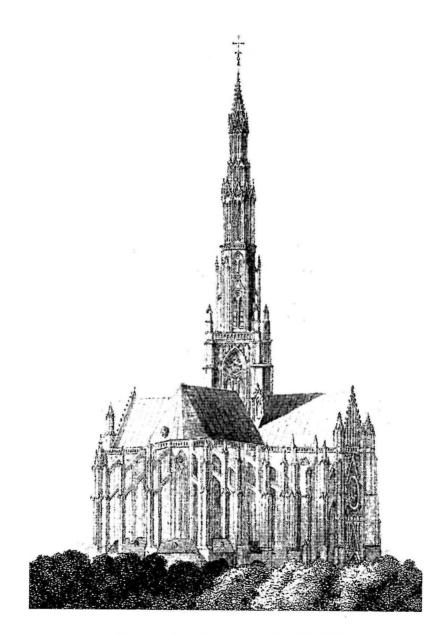
Beauvais Cathedral as completed in 1569. J. M. Fugère sculp. Frontispiece from Desjardins

There seems little doubt, however, that had the advice of the King's masons been taken in 1571, and the crossing piers braced, the tower might be standing today. It seems that the structure, from 1569, when the tower was completed, until 1573, when it fell, was never truly in equilibrium. Desjardins reports¹ numerous small movements, and Leblond² reports fractures occuring, during these 4 years.³

The structural system of a massive tower supported by four unbraced piers would be liable to "drift", the movement restrained by tensile and shearing stresses developed in the mortar, and by possible interlocking of stones. Eventually, however, the columns would have been pushed so far out of true as to be useless. The Chapter was right to call a halt in 1605; "le temps n'était plus à bâtir des cathédrales."
