- ENGINEERING MEDIEVAL CATHEDRALS

BEAUVAIS CATHEDRAL

STRUCTURAL ANALYSIS AND COMPARISON

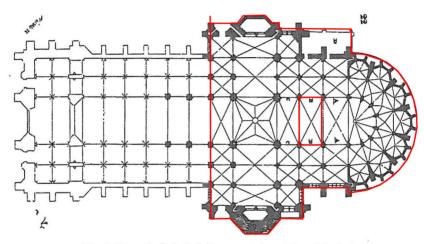
as it was built, so that the nave and choir are different in structure; in the case of Beauvais, only one *typical* bay was ever completed, i.e. the second bay east of the crossing (B in Fig. 1). The next bay east (A) is already part of the chevet; the previous bay (C) is part of the transept. In fact this single bay is structurally the most critical of the choir, receiving no additional buttressing from either the chevet or the transept, and it is this bay that Benouville analysed, and which will be discussed here. Corroyer's cross-section¹ of the "typical" bay is shown in Fig. 2, and Benouvilles' "coupe restaurée" in Fig. 3. Comparing these two figures, it will be seen that the present structure has two extra flying buttresses, added in the sixteenth century; these will be removed from the analysis, which will deal, as far as possible, with the completed choir of 1272.

Fig. 1. Beauvais Cathedral: Reconstruction of the original plan by *Viollet-le-Duc*.

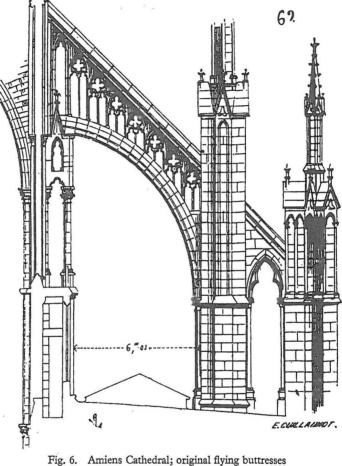
(Viollet-le-Duc).

rib is computed from the wind pressure acting on the roof and part of the wall. The two ribs are only partially separated for the relatively low cathedral considered by Ungewitter; a complete separation was made at Amiens, Fig. 6,1 necessitated by the taller construction. The solution at Amiens was not satisfactory, almost certainly because of the tracery connection between the two ribs,²

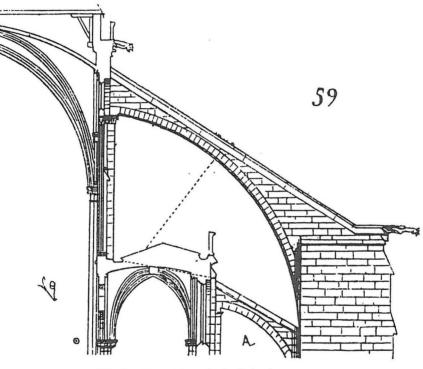
The height of the parapet is, in turn, related to the amount of doming given to the vaults by the designer. The parapet will be high if the vaults are virtually cylindrical, with level soffits, as at Beauvais, Fig. 3, or Reims, Fig. 7. If the vaults are strongly domed, as at Notre Dame, Paris, Fig. 8,³ then it may be possible to use a single flying buttress to counteract both the vault thrust and the wind forces.

Fig. 8. Notre Dame, Paris; flying buttresses (*Viollet-le-Duc*).

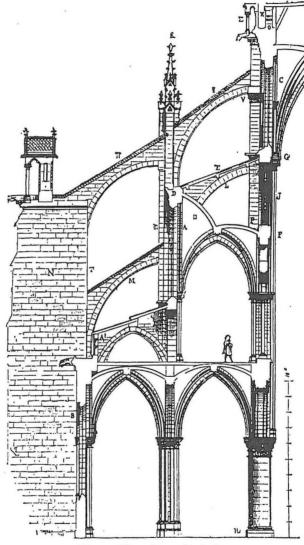
Now the great flying buttresses at Paris span over two side aisles, and a buttress of these dimensions is unusual. It was more common to use an intermediate pier, as, indeed, was the case originally at Paris; the late twelfth century design is shown in Fig. 9.⁴ This design was destroyed, and rebuilt in its present form, et about the middle of the thirteenth century.⁵ Similarly, the *choir* at Reims, which has two side aisles on each side, uses intermediate piers in the buttressing system. And, of course, Beauvais has the intermediate buttresses in porte-à-faux.

Fig. 9. Notre Dame, Paris; late twelfth-century design (Viollet-le-Duc).
